FINAL REPORT
F SERIES
STAGING
MOCK-UP INVESTIGATION

Project CLASP was an extensive investigation of "E" and "F" Series Atlas Missile System failures in order to analyze, isolate and define the critical areas associated with staging, guidance and other problems that may have been defined and to devise and prepare design fixes to correct the problems.

An investigation of possible problem areas in the staging of Atlas "E" and "F" missiles was conducted as a portion of the program in order to determine the mode of failure of 71E, 6F, and 138F. The failure of the three missiles was directly attributed to loss of sustainer hydraulic pressure after initiation of staging.

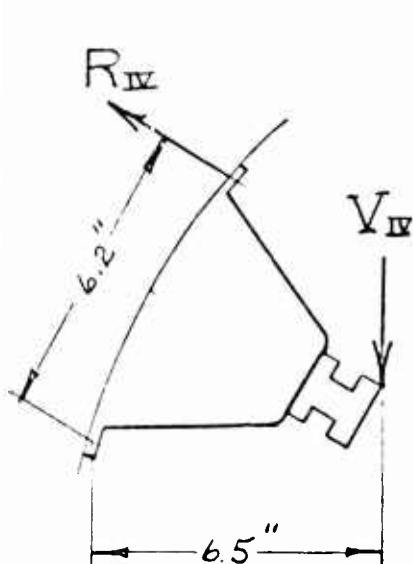
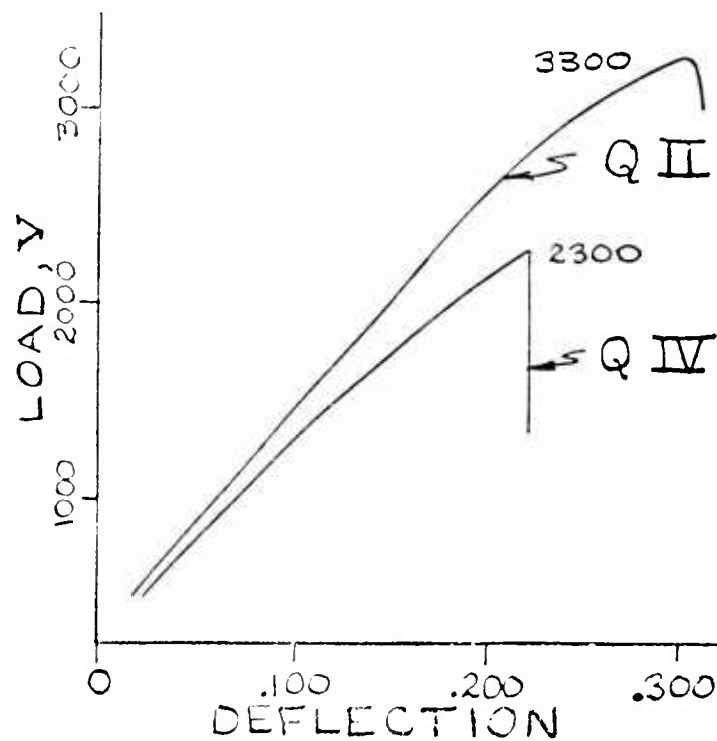
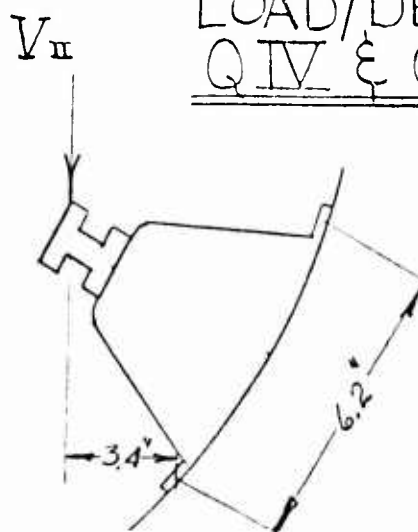
FIG. 5.8.1

JETTISON SLIDE
PEDESTAL TEST

$$R_{IV} = \frac{6.5}{6.2} \times V_{IV}$$

$$R_{II} = \frac{3.4}{6.2} \times V_{II}$$

LOAD/DEFLECTION
QIV & QII PEDESTAL

The pedestal failed upon reaching 2300 lbs. with .226 ins. vertical deflection and .050 rotation of the slide. Strain gage readings followed the loading until 2100 pounds. At this applied load the strain gage read 1420 lbs. and after that it read a gross error which indicated excessive load.

The pedestal failed approaching 3340 lb. load .372 ins. vertical deflection and strain gage readout of approximately 3250 lbs.

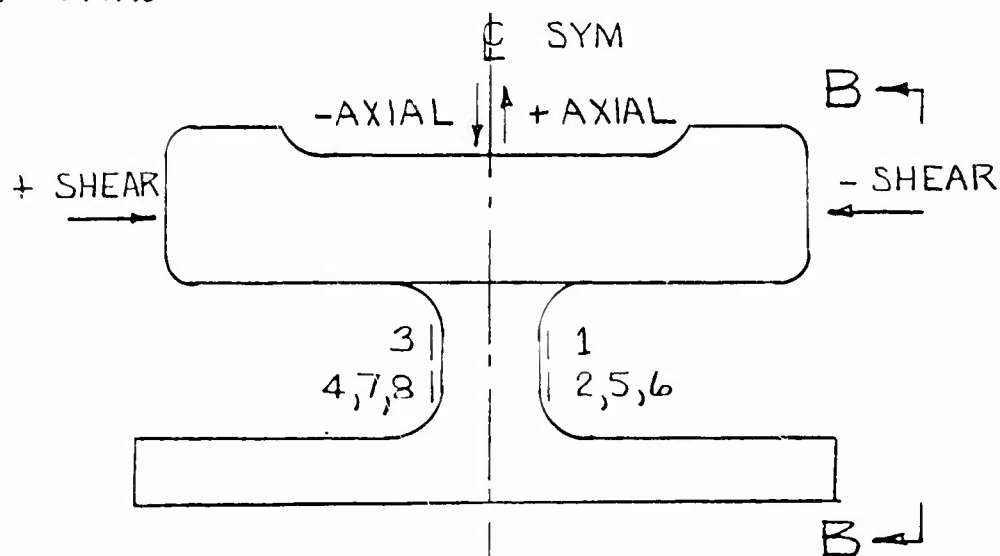
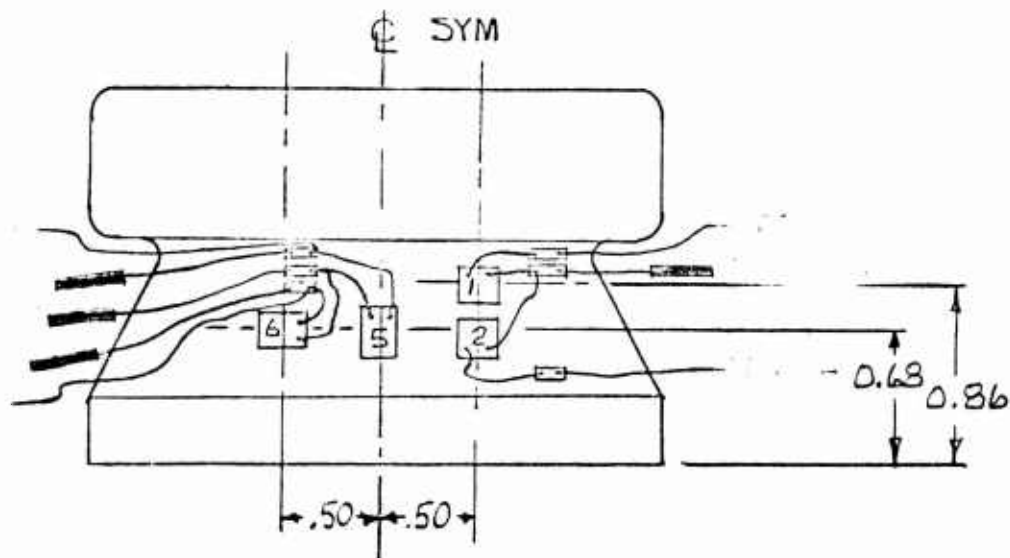
FIG. 6.1.2

INSTRUMENTATION - FWD JETTISON
SLIDE QUADS II

VIEW B-B

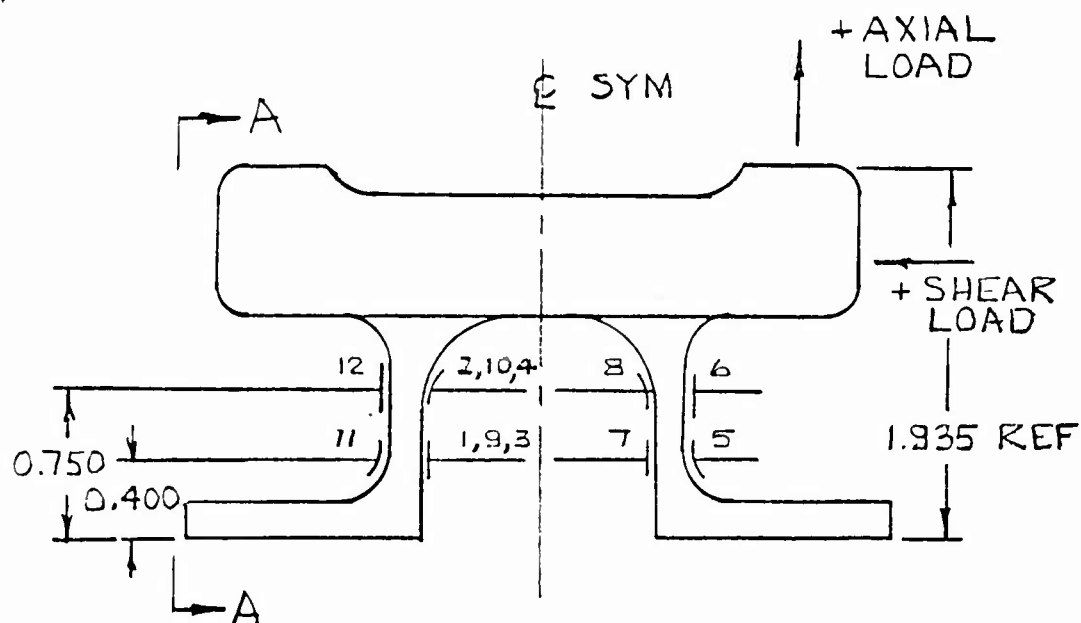
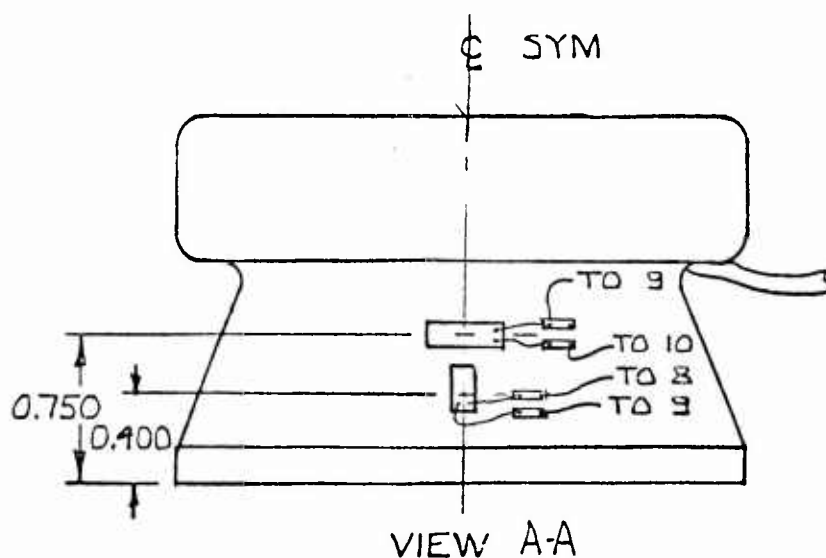
FIG 6.1.1

INSTRUMENTATION - FWD JETTISON
SLIDE QUADS II

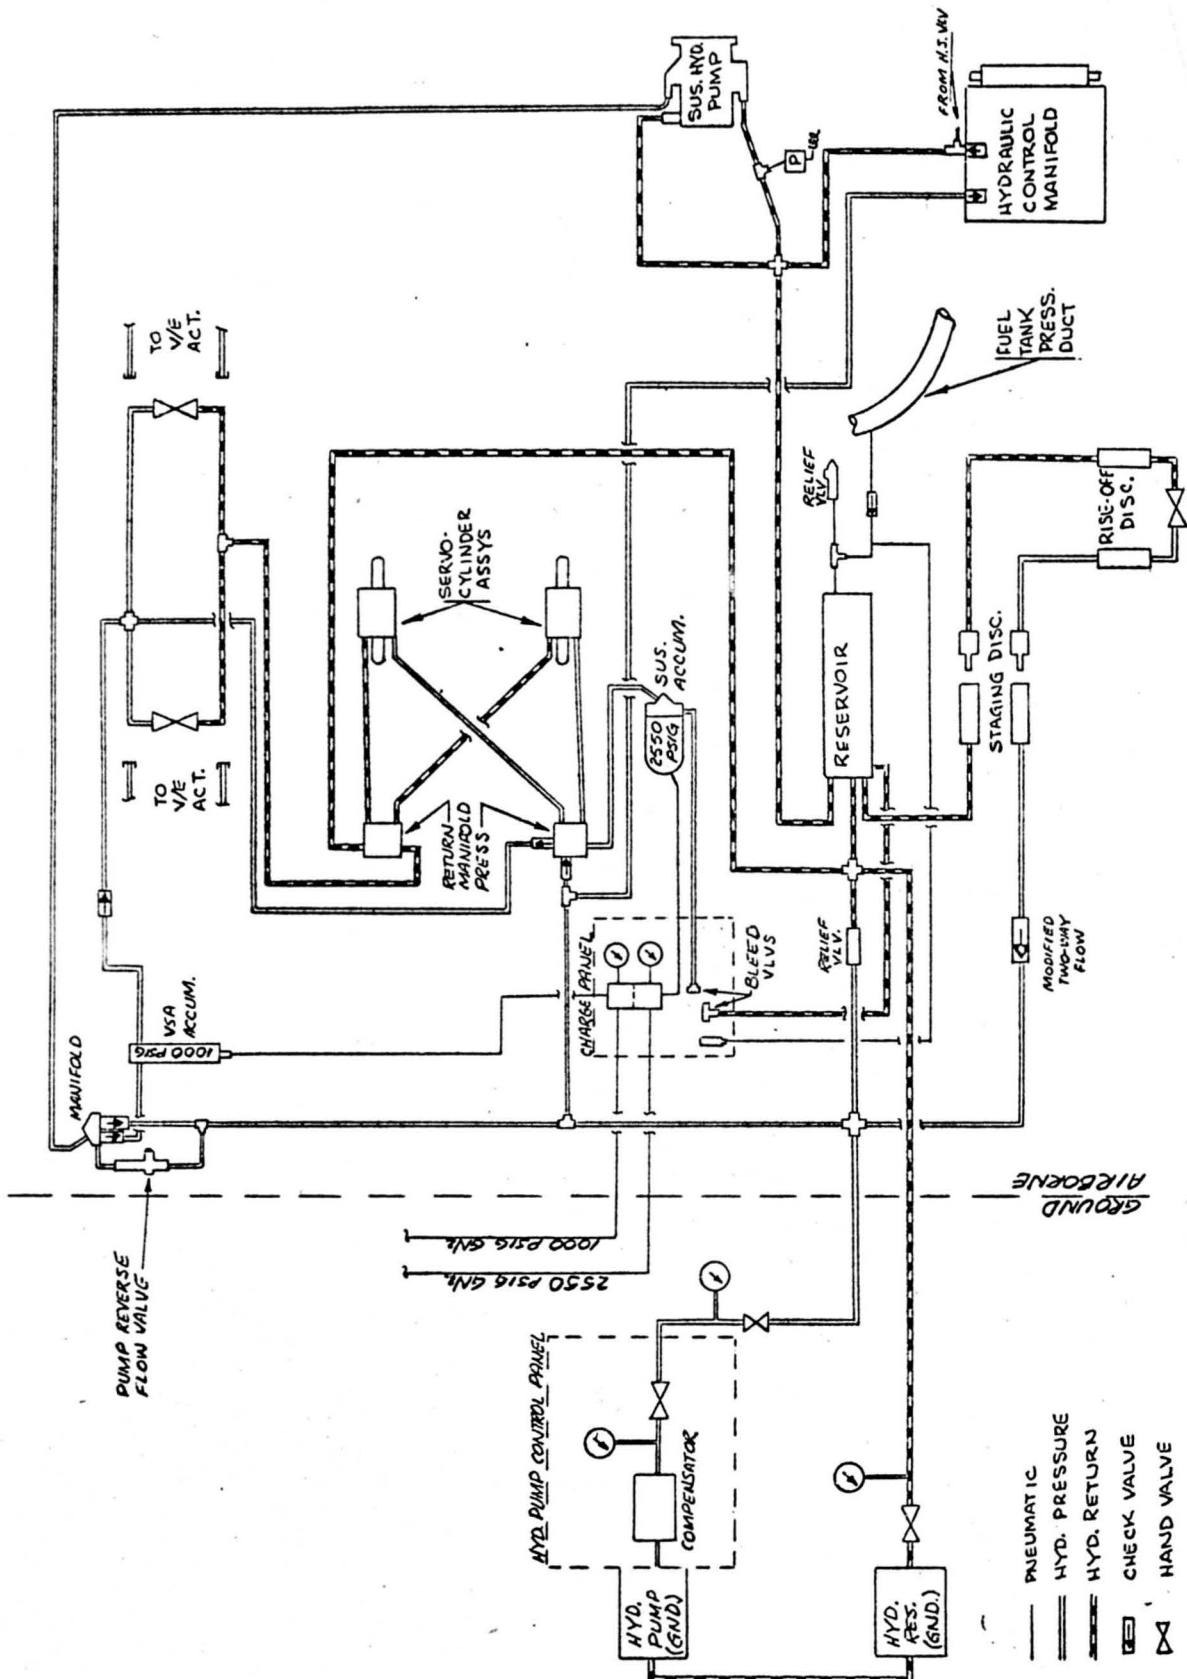
FIG. 4.1- SUSTAINER HYDRAULIC SYSTEM - "F" SERIES MOCK-UP

A flow capacity of 10 gpm at 3750 PSIG will be required for system bleeding. All bleeds will conform to normal practices except the sustainer engine will not be gimbaled. A reservoir level drop test will be required to verify bleed adequacy. Provision must be made to bleed the pressure and return hydraulic lines between the rise-off and staging disconnects.

See Figure 4.1 for schematic of system.

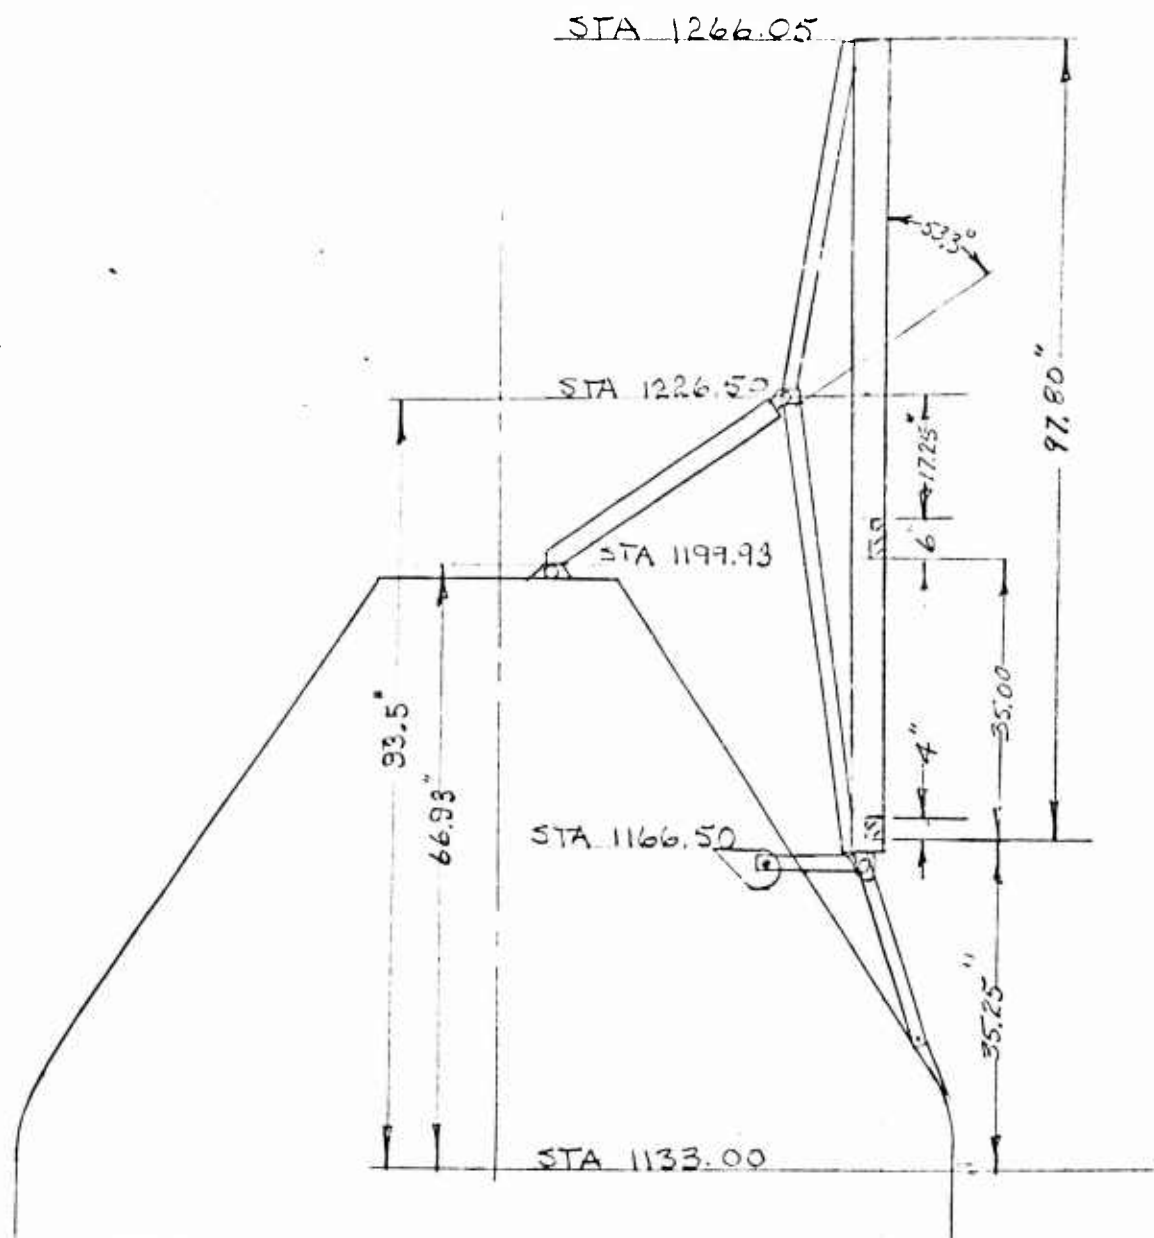
APPENDIX B
SHEET 1

JETTISON SHOE LOCATION
AT MATED POSITION
